# Installing a new High-Speed Seal on a Vortech Supercharger

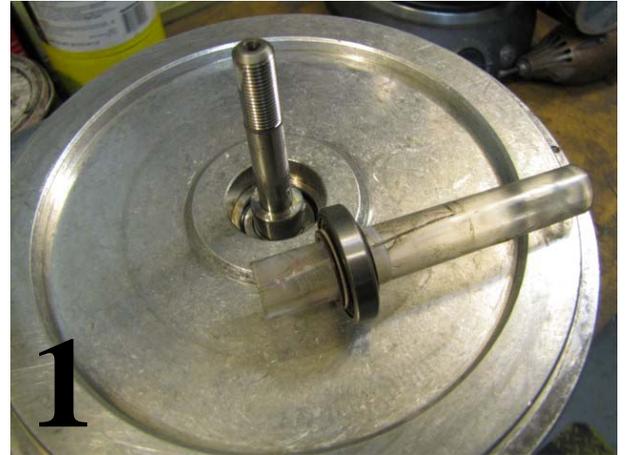
In picture 1, the seal is on the shaft sleeve, and the sleeve has been wiped with grease.

When installing seals, you should use a shaft sleeve to protect the seal from becoming cut during the installation. Wipe a little grease within the lips of the seal so they do not run dry. I like to use high-temp wheel bearing grease for this.

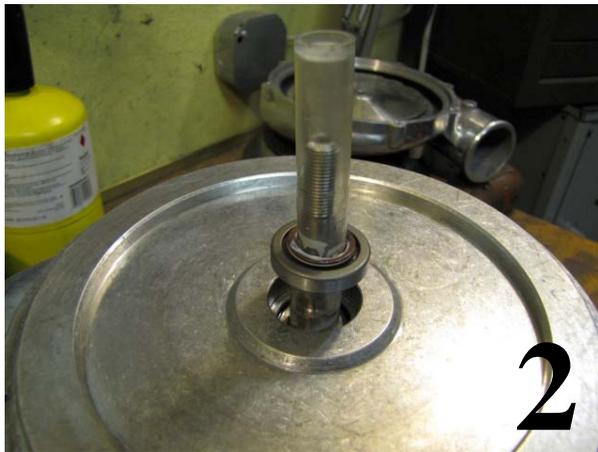
In Picture 2 the shaft sleeve has been placed over the impeller shaft of the Vortech supercharger.
