## <u>Raptor V/R (all models) SIMPLE BELT</u> REPLACEMENT METHOD

Updated: 01/03/2013

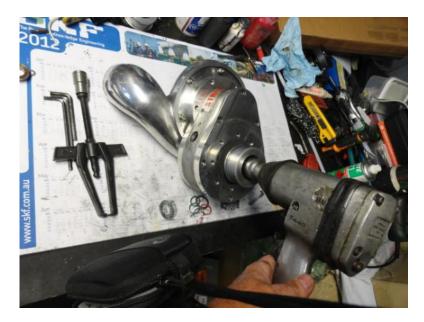
Place supercharger on workbench and remove the 24mm nut with impact wrench

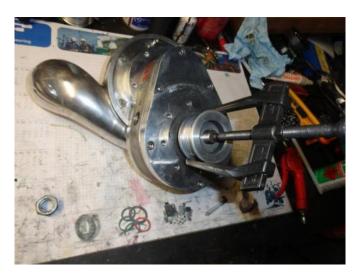
Remove drive pulley using a puller – sometimes heat may be needed for pulley to release from shaft easily

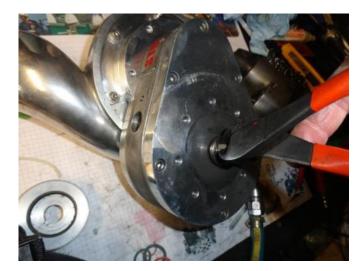
Remove key from shaft using side cutters, most efficient – lever key out

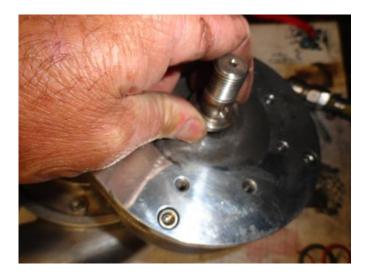
Remove pulley spacer - IF your charger has one, some pulleys have integral spacer

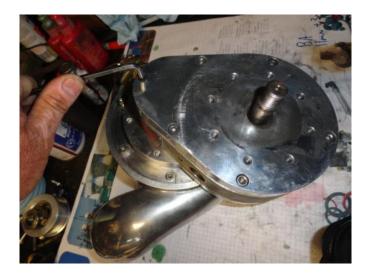
Loosen and remove the 6 socket headed screws from front of transmission

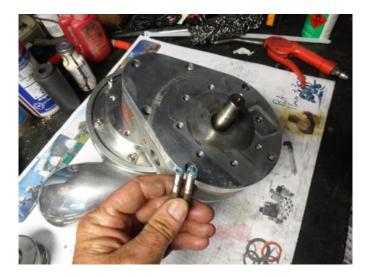
Apply grease to polished ends

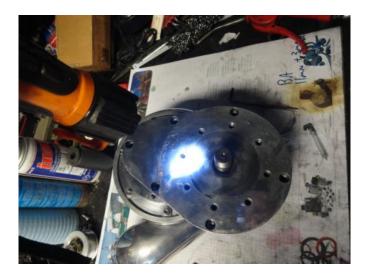
Take a torch and look into screw hole as shown, turn shaft until you see the peak of a pulley tooth at end of hole

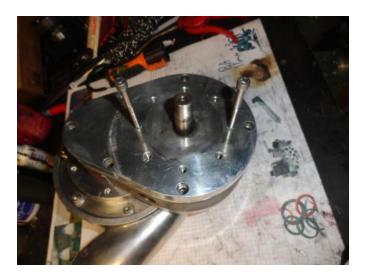
Insert the 2 screws with polished and greased ends into the holes as shown, screw in until they contact the pulley – then stop

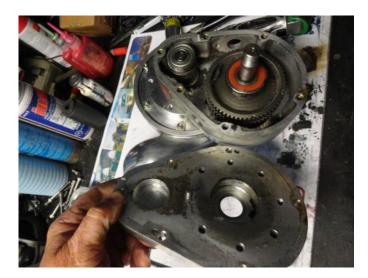
This is what you will now see, fibreglass fibers and rubber belt/dust pieces. Vacuum out all these materials, wear dust mask if allergic to dust

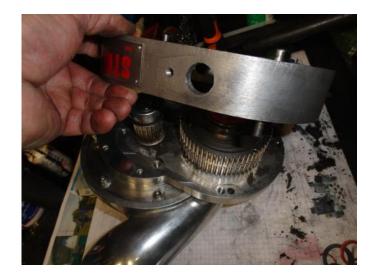
You can now remove the central cowl from the transmission, a few gentle taps with a rubber mallet will assist in loosening this part. The entire drive will now be exposed.

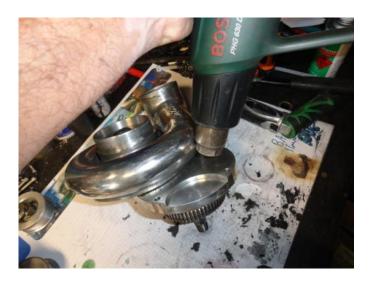
Turn supercharger over and heat rear section in approximate area of the low speed bearing, make the area hot to touch.

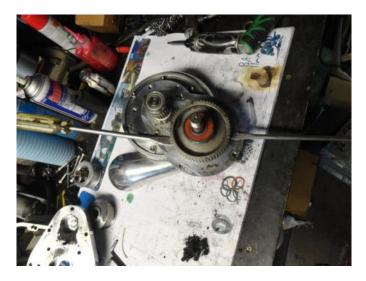
Take 2 tools (screwdrivers in this case) and then lift out the low speed shaft assembly

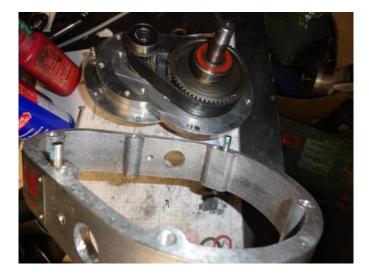
Grease the dowels of cowl as shown, refit cowel

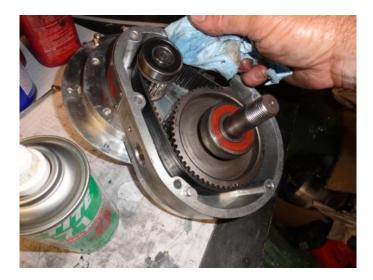
Using 7471 primer, clean outer edge/race of bearings and also bearing recesses in front alloy plate of transmission

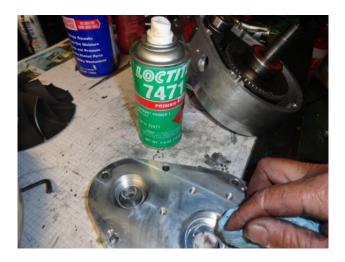
Bearing recesses being cleaned
