928 Motorsports Supercharger Installation

Porsche 968 Idler Pulley Upgrade

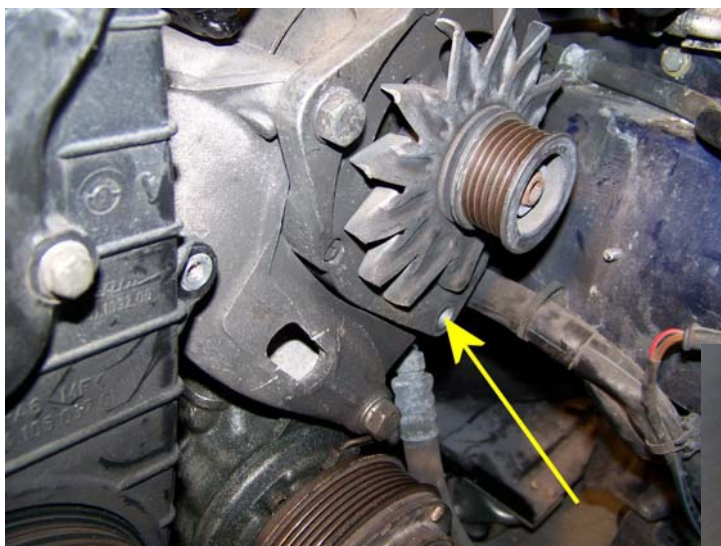
One problem that the 968 has is very little belt wrap on the alternator pulley. This causes the 968 owner to over-tighten their alternator belt (which often breaks the belt tensioner turn-buckle), or suffer with poor charging.

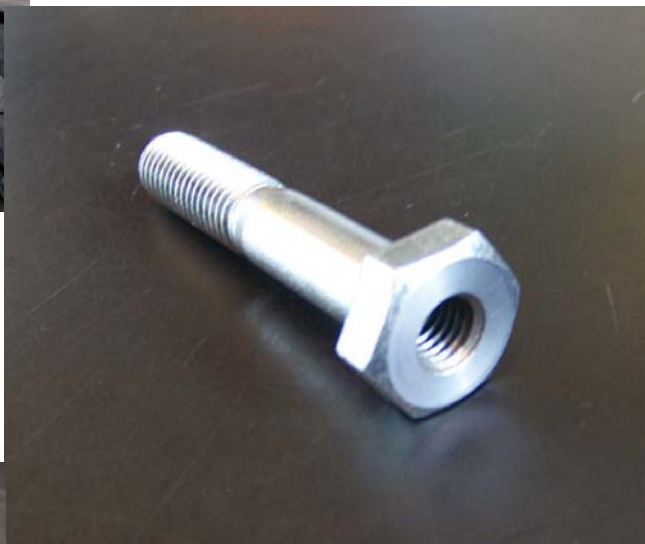
Remove the lower alternator mounting bolt as shown. (Don't worry, the alternator will not move and is held in place by the upper bolt)

Find the special alternator bolt provided that looks like this and install it.

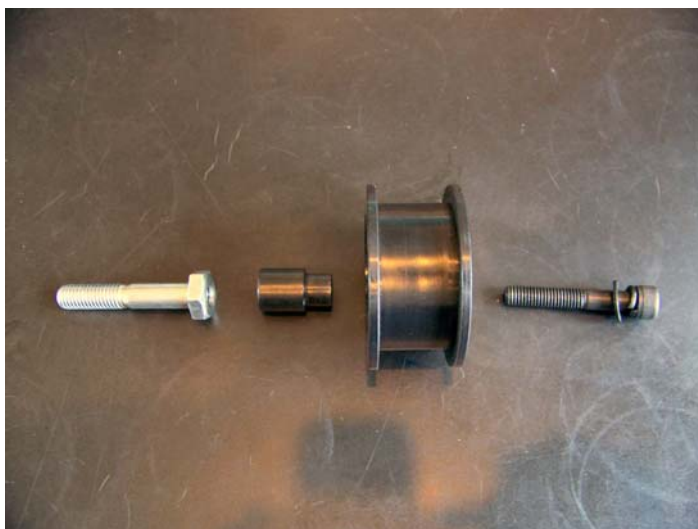
Here is a picture of the Idler Pulley Upgrade exploded so you can see which pieces go in which direction.

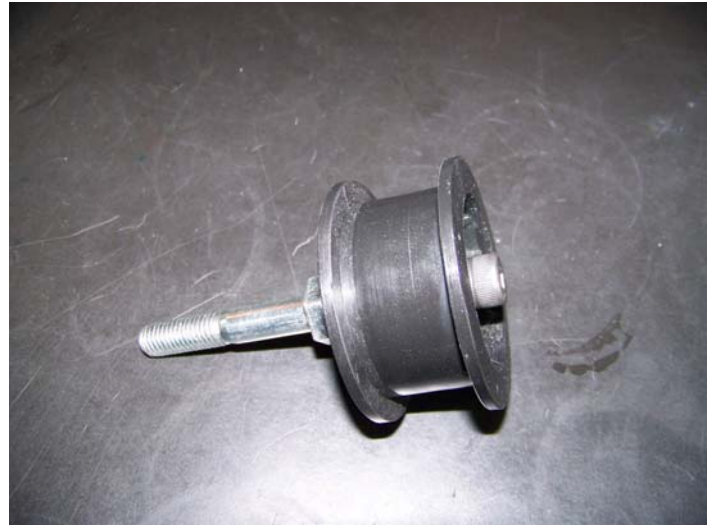
Now install the Idler Pulley by mounting it onto the special alternator bolt.
