928 Motorsports Supercharger Installation

Porsche 968 Idler Pulley Upgrade

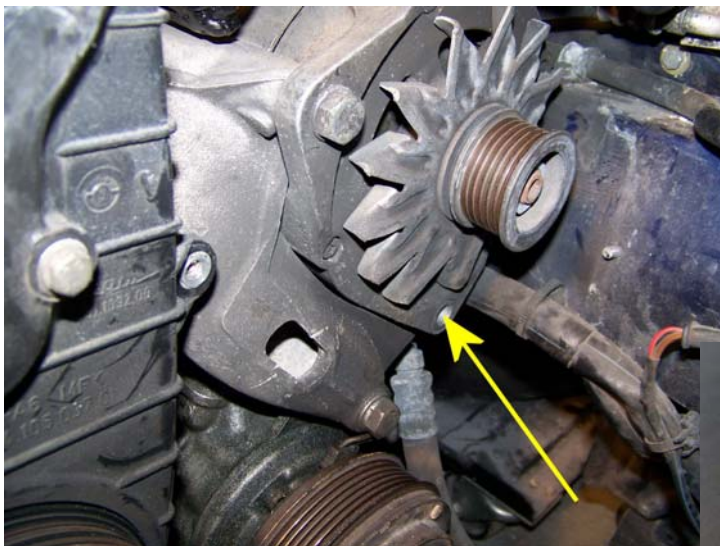
One problem that the 968 has is very little belt wrap on the alternator pulley. This causes the 968 owner to over-tighten their alternator belt (which often breaks the belt tensioner turn-buckle), or suffer with poor charging.

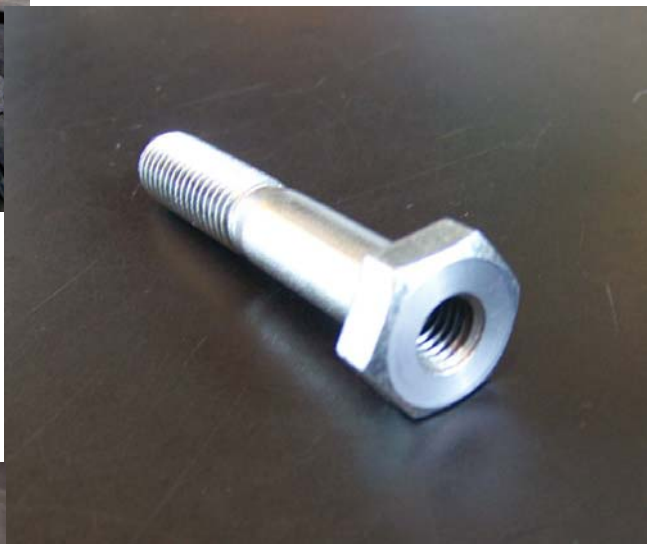
Remove the lower alternator mounting bolt as shown. (Don't worry, the alternator will not move and is held in place by the upper bolt)

Find the special alternator bolt provided that looks like this and install it.

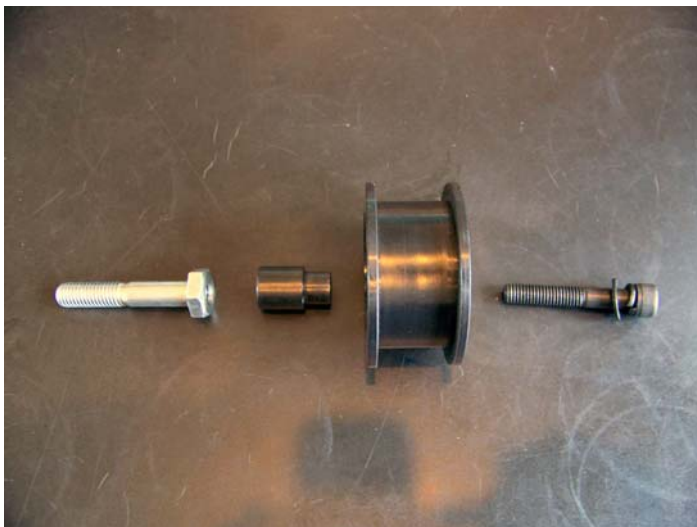
Here is a picture of the Idler Pulley Upgrade exploded so you can see which pieces go in which direction.

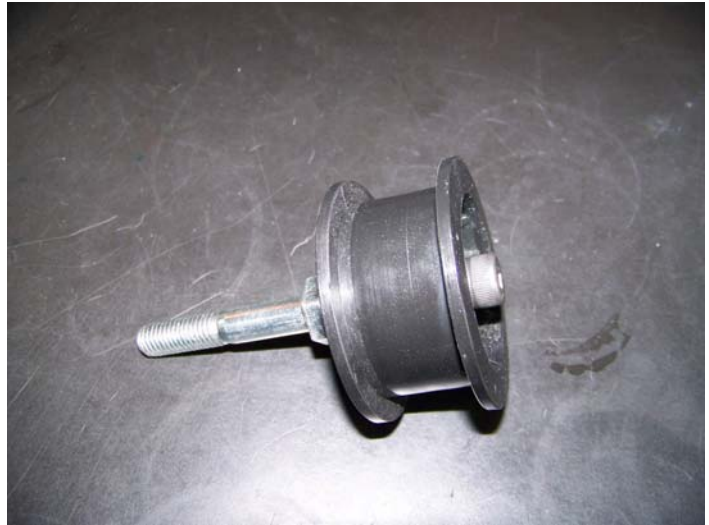
Now install the Idler Pulley by mounting it onto the special alternator bolt.

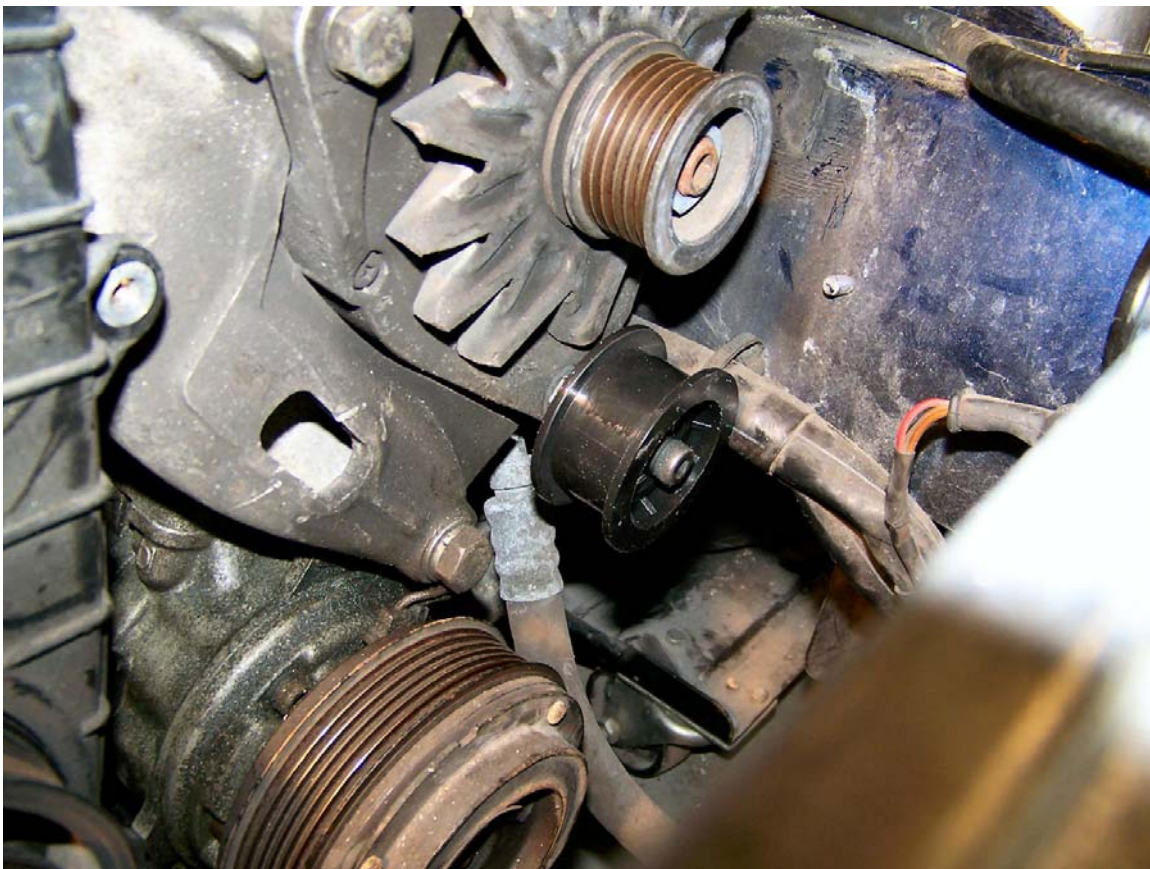
This is the finished installation of the Idler Pulley Upgrade.

Now you have more belt wrap on your idler pulley, and do not have to over-tighten the belt just to stop slippage!
